LONDON- WEST MIDLANDS ENVIRONMENTAL STATEMENT

CFAg | Central Chilterns

Survey reports (CH-004-009)

Cultural heritage

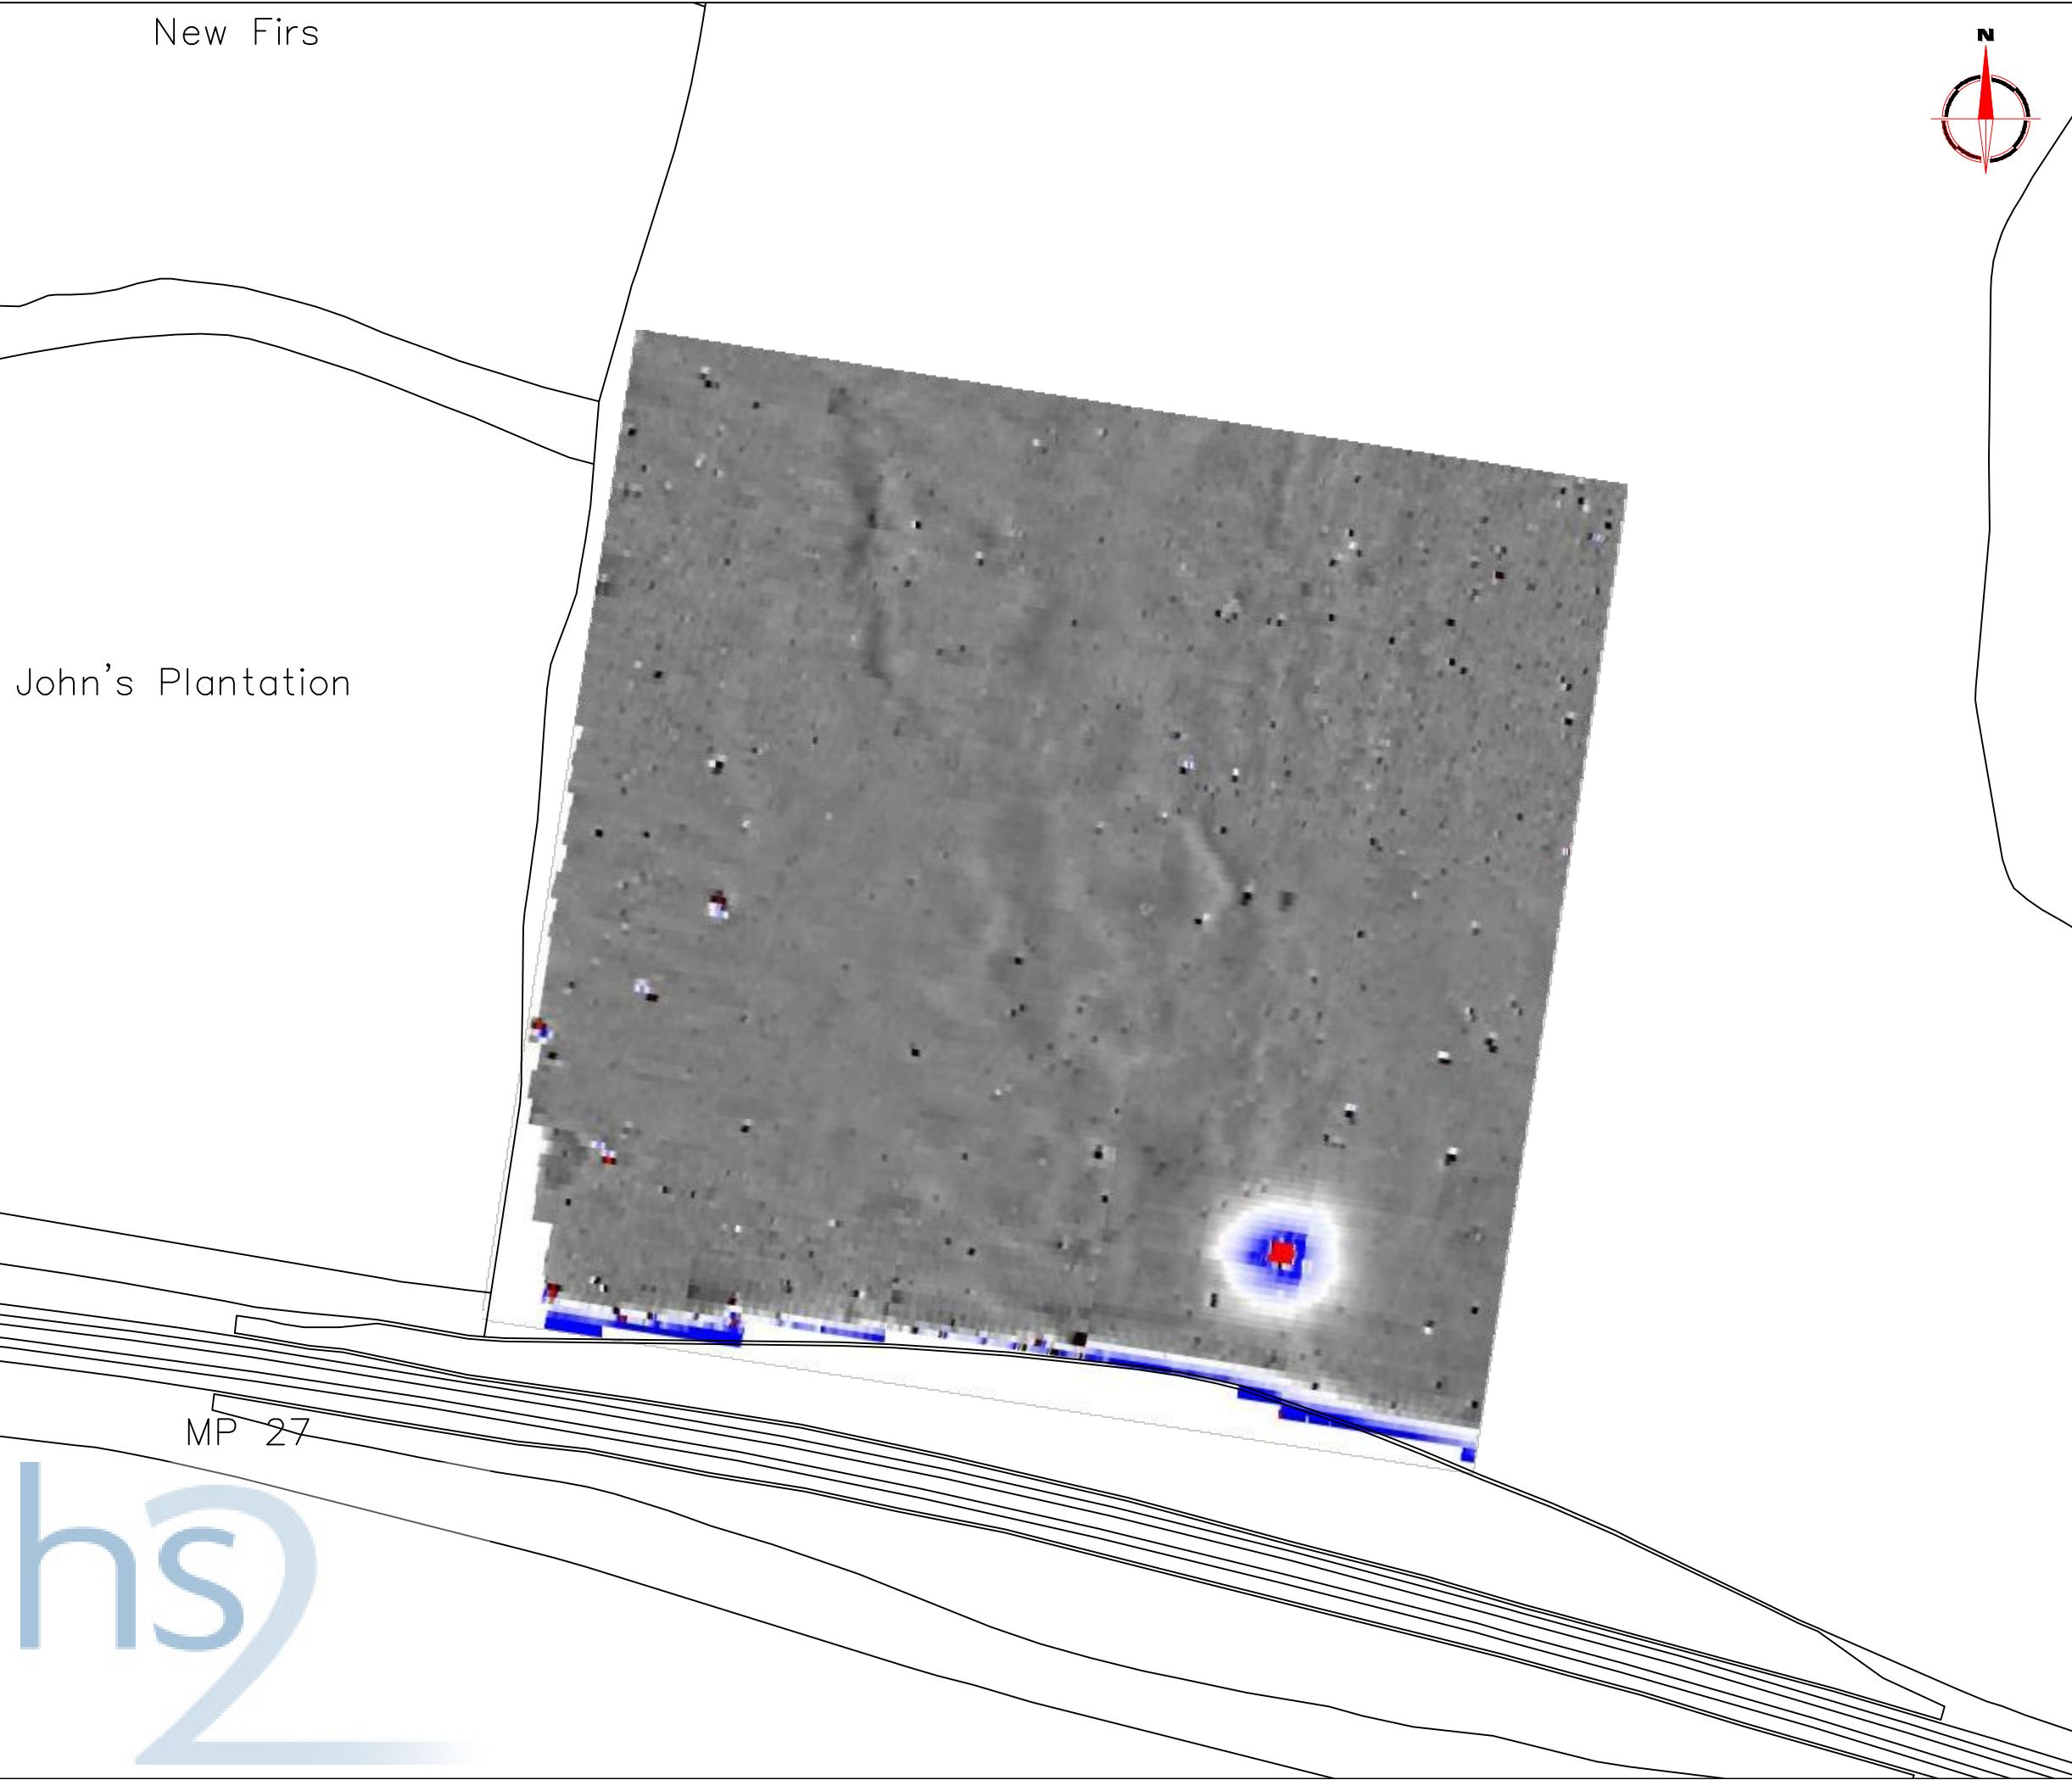
Plot	Checked by	Issue No.
A3	DGE	01
Survey date	Drawn by	Figure No.
JUNE 2013	BPM	CH-004-09.08

Amendments		
Issue No.	Date	Description
-	-	-
-	-	-
© Stratascan Ltd - 2013		
<div>Plotting parameters</div> <div>Maximum + 100nT (red)</div> <div>Minimum - 100nT (blue)</div> <div><div></div><div>+ 100nT</div><div>- 10nT</div><div>- 10nT</div><div>- 100nT</div></div>		
Client		
HS2 Ltd		
Project Title		Job No. J3363-MVOAB
GEOPHYSICAL SURVEY - HS2 LONDON - WEST MIDLANDS: CFA 09 - AREA MVOAB - MANTLES WOOD		
Subject		
COLOUR PLOT OF GRADIOMETER DATA SHOWING EXTREME VALUES		
<div>STRATASCAN™</div> <div>GEOPHYSICS FOR ARCHAEOLOGY AND ENGINEERING</div> <div>VINEYARD HOUSE T: 01684 592266 UPTON UPON SEVERN E: info@stratascan.co.uk WR8 0SA www.stratascan.co.uk</div> <div><div>EUROPEAN GPR ASSOCIATION</div><div>sumo Survey Services</div><div>SUMO GROUP MEMBER</div><div>ims ISO 9001 certified</div><div>UKAS QUALITY MANAGEMENT 9001</div><div>ims ISO 14001 certified</div><div>UKAS ENVIRONMENTAL MANAGEMENT 14001</div></div> <div>Scale 1: 1000</div> <div>0m 10 20 30 40 50</div>

- 3.1.7 The magnetometer survey was carried out with Bartington Grad 601-2 fluxgate gradiometers, collecting data every 0.25m along traverses 1m apart. Data processing has been performed as appropriate using an in-house software package employing the following processing steps: Destripe (removes striping effects caused by zero point discrepancies between different sensors and walking directions) and Destagger (removes zig-zag effects caused by inconsistent walking speeds on sloping, uneven or overgrown terrain).

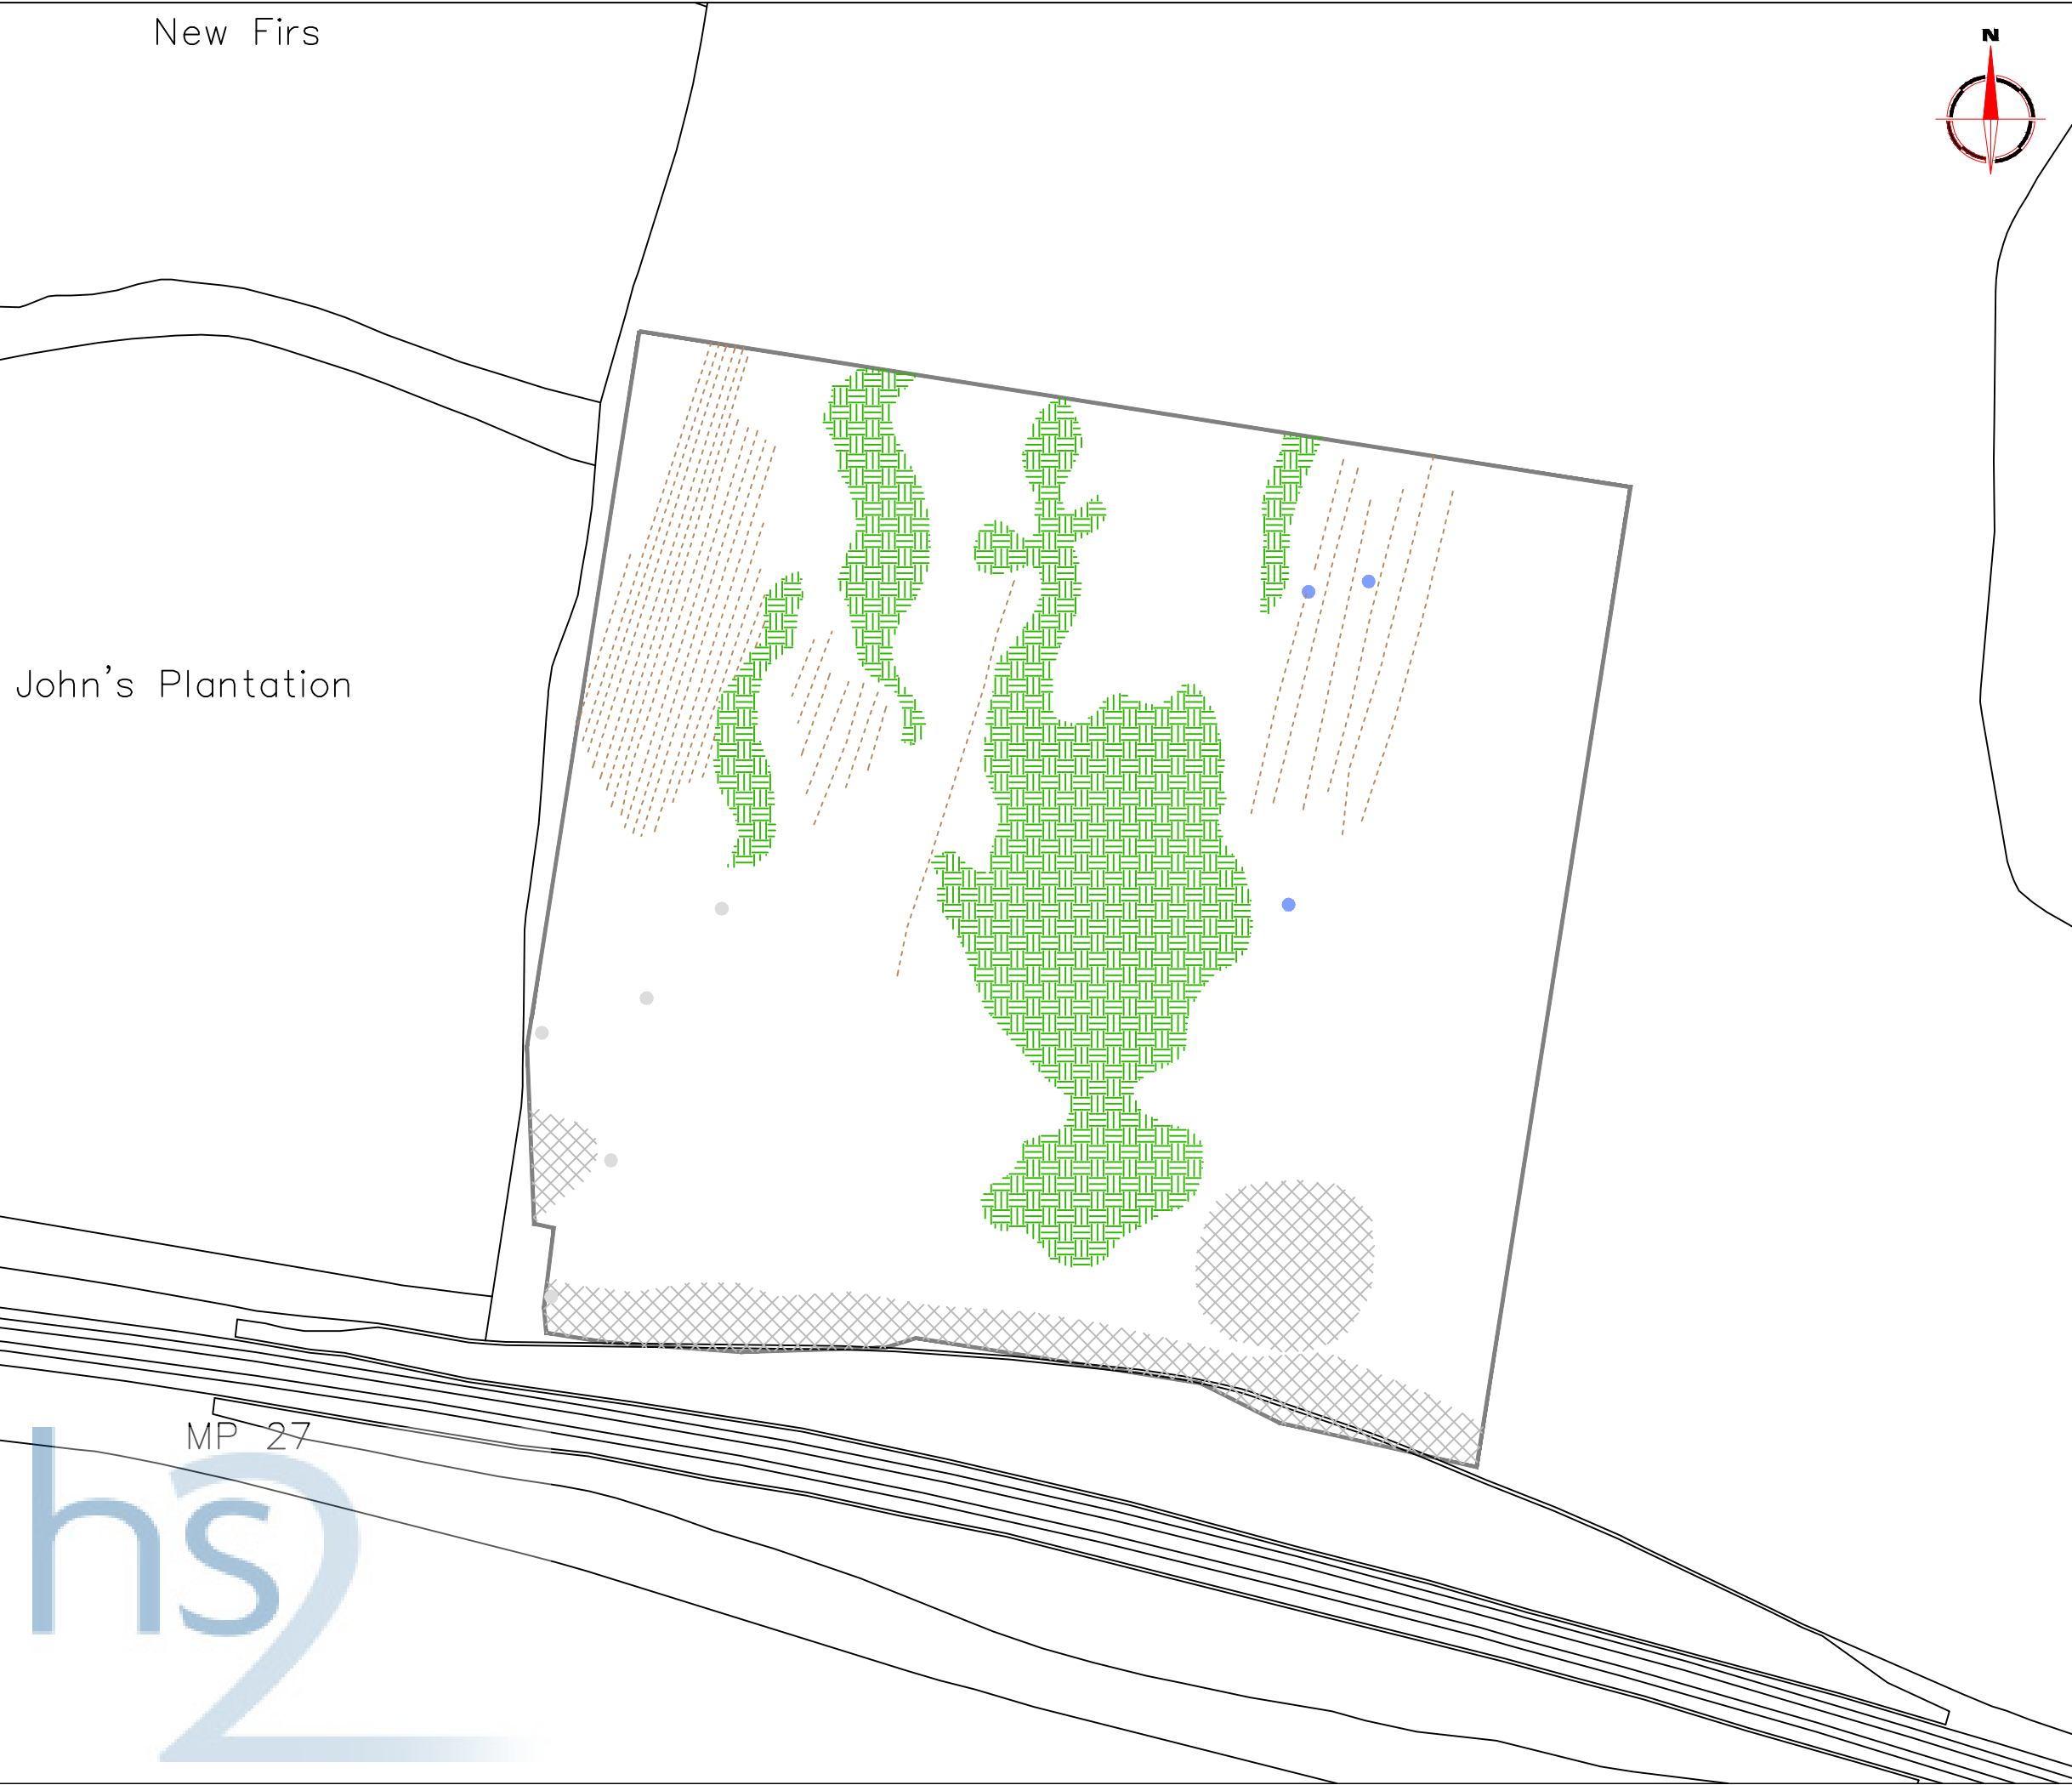
- 3.1.18 Three discrete positive responses noted in the north-eastern part of the site may indicate in-filled pits of possible archaeological interest although these responses may also be of natural origin (see Figure CH004.09.10).
- 3.1.19 The parallel linear responses seen in the northern part of the site are indicative of agricultural activity, and the close spacing of the responses is suggestive of a modern origin. The amorphous magnetic variation observed within this area of the site is indicative of a natural response associated with variations within the geology or pedology of the site.
